Mission Success Starts with Safety

Lessons Learned in Design and Process Reliability

Fayssal M. Safie, Ph. D.,

RAM VI Workshop

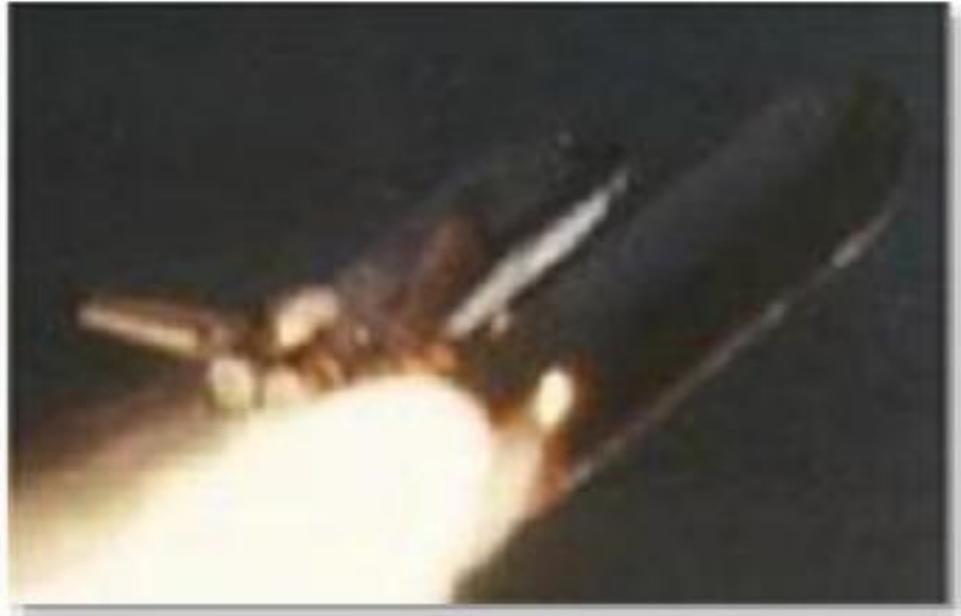
Photograph of the 51-L launch at approximately 58.82 seconds after launch shows an unusual plume in the lower part of the right hand SRB.

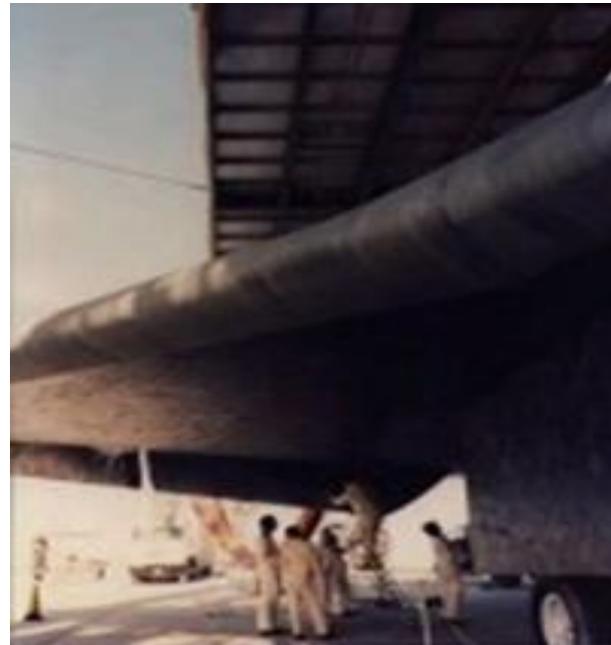
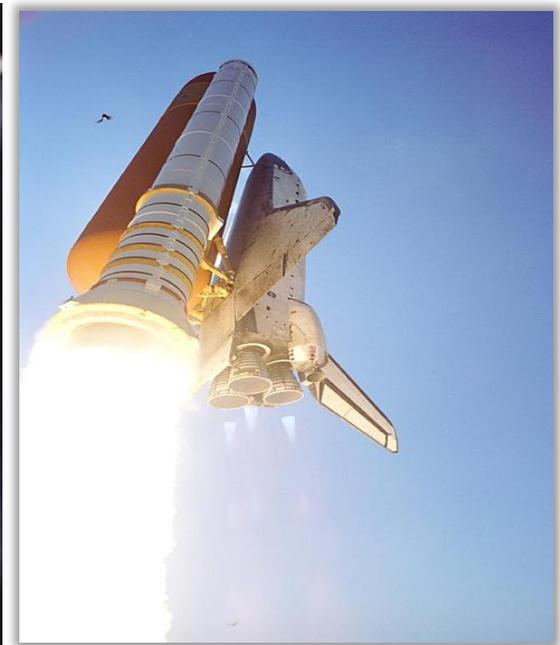
- Breach in the Thermal Protection System caused by the left bipod ramp insulation foam striking the left wing leading edge.
- There were large gaps in NASA's knowledge about the foam.
- cryopumping and cryoingestion, were experienced during tanking, launch, and ascent.
- Dissections of foam revealed subsurface flaws and defects as contributing to the loss of foam.
