Machine Learning Applied in Rotating Machinery for Anomalies Detection and Remaining Useful Life (RUL) estimation - Case Study

1. Gearbox Technical Info
2. Sensors Hardware Setting
3. Vibration and Temperature Monitoring Software Setting.
4. Vibration Trend Analysis
5. Failure Diagnostic
6. Failure Modes Tags
7. Prognostics of Failure to Identify the Remaining Useful Life.
8. Conclusions.

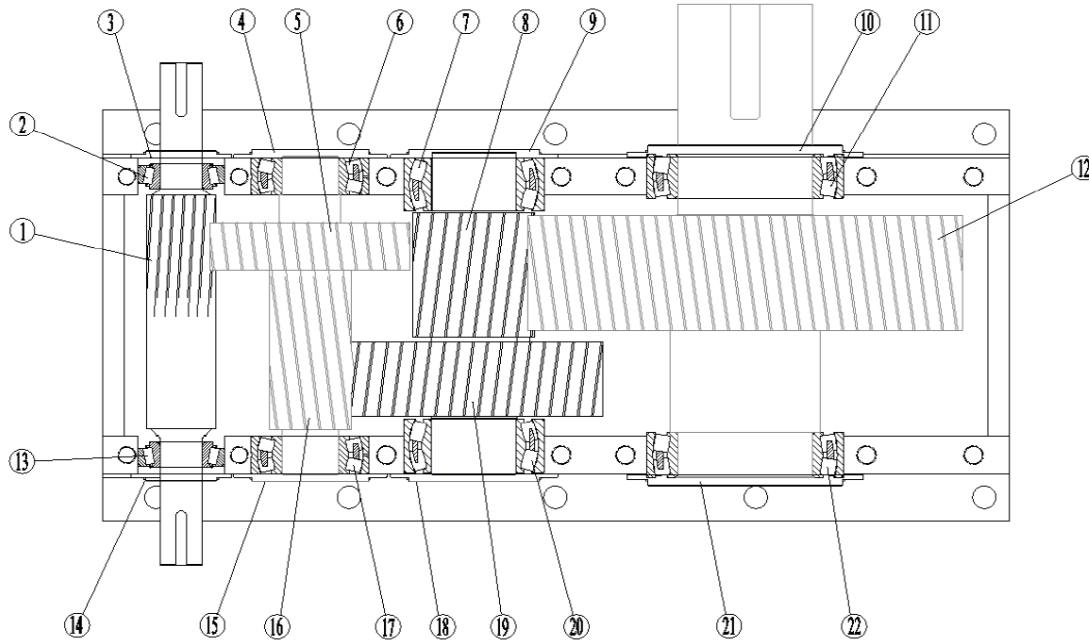
Technical Info

MODEL	647Z3-S
MO#	96-075332
RATIO	48.48
RATED HP	3300 HP
MOTOR HP	1650 HP
MOTOR RPM	900 RPM
UNIT WEIGHT DRY	53250 LBS
LS COUPLING	18F KOPFLEX
HS COUPLING	FALK 1140T10

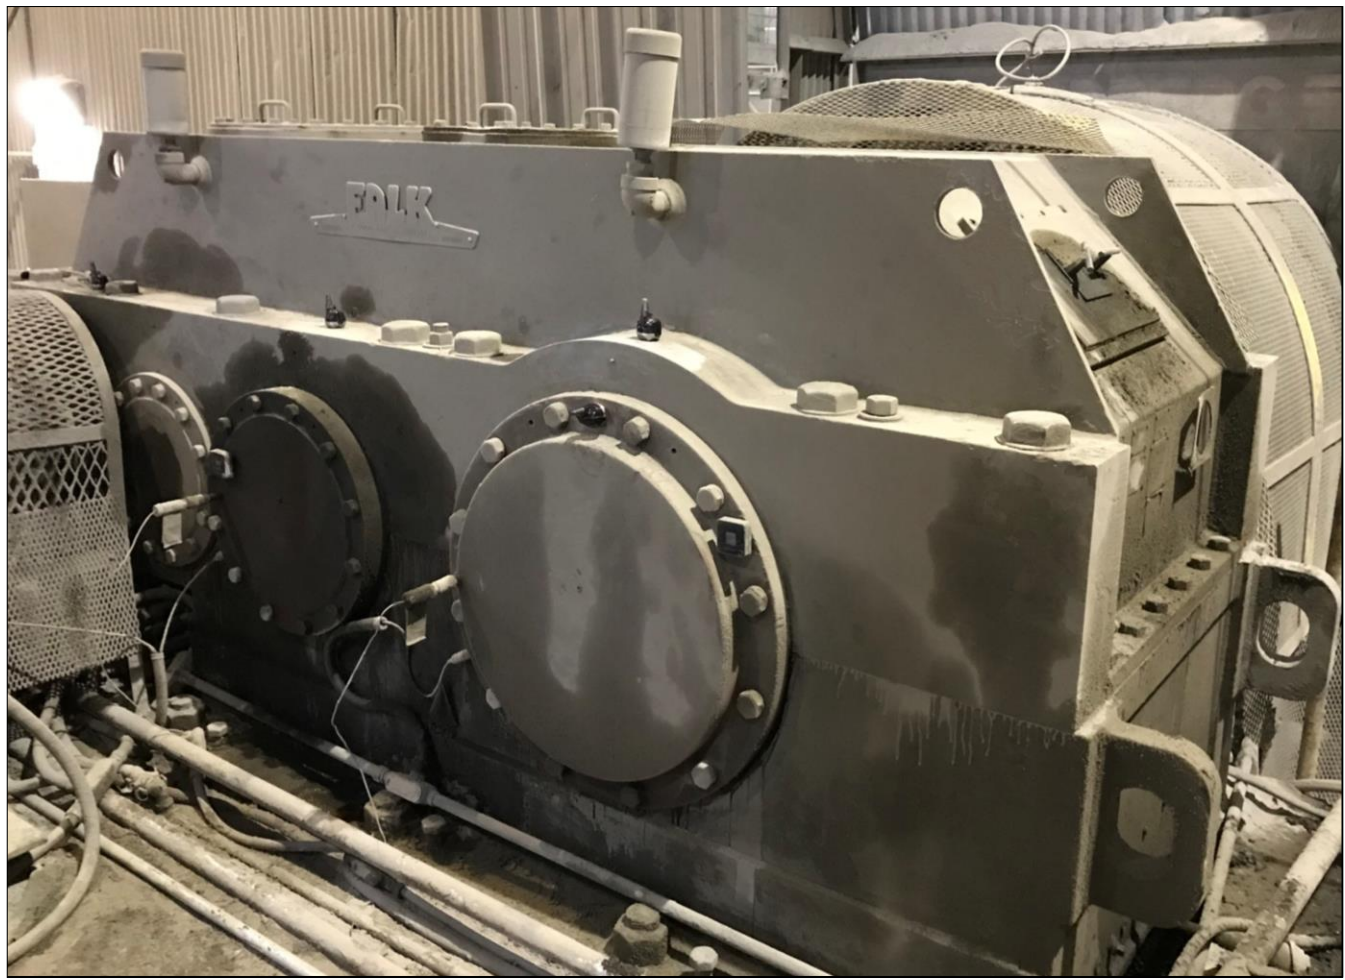
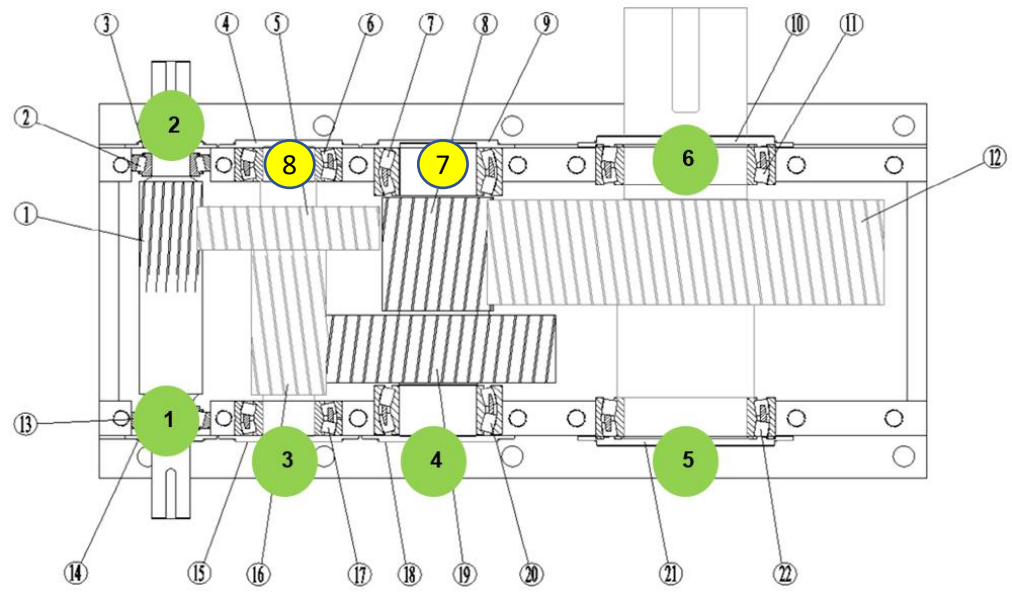
Sensors Hardware Setting

The green circles show the place (point) where the Triaxial wireless sensors are installed to measure vibrations and temperature.

- Points # 1 and 2 = 1st Shaft
- Point # 3 = 2nd Shaft
- Point # 4 = 3rd Shaft
- Points # 5 and 6 = 4th Shaft

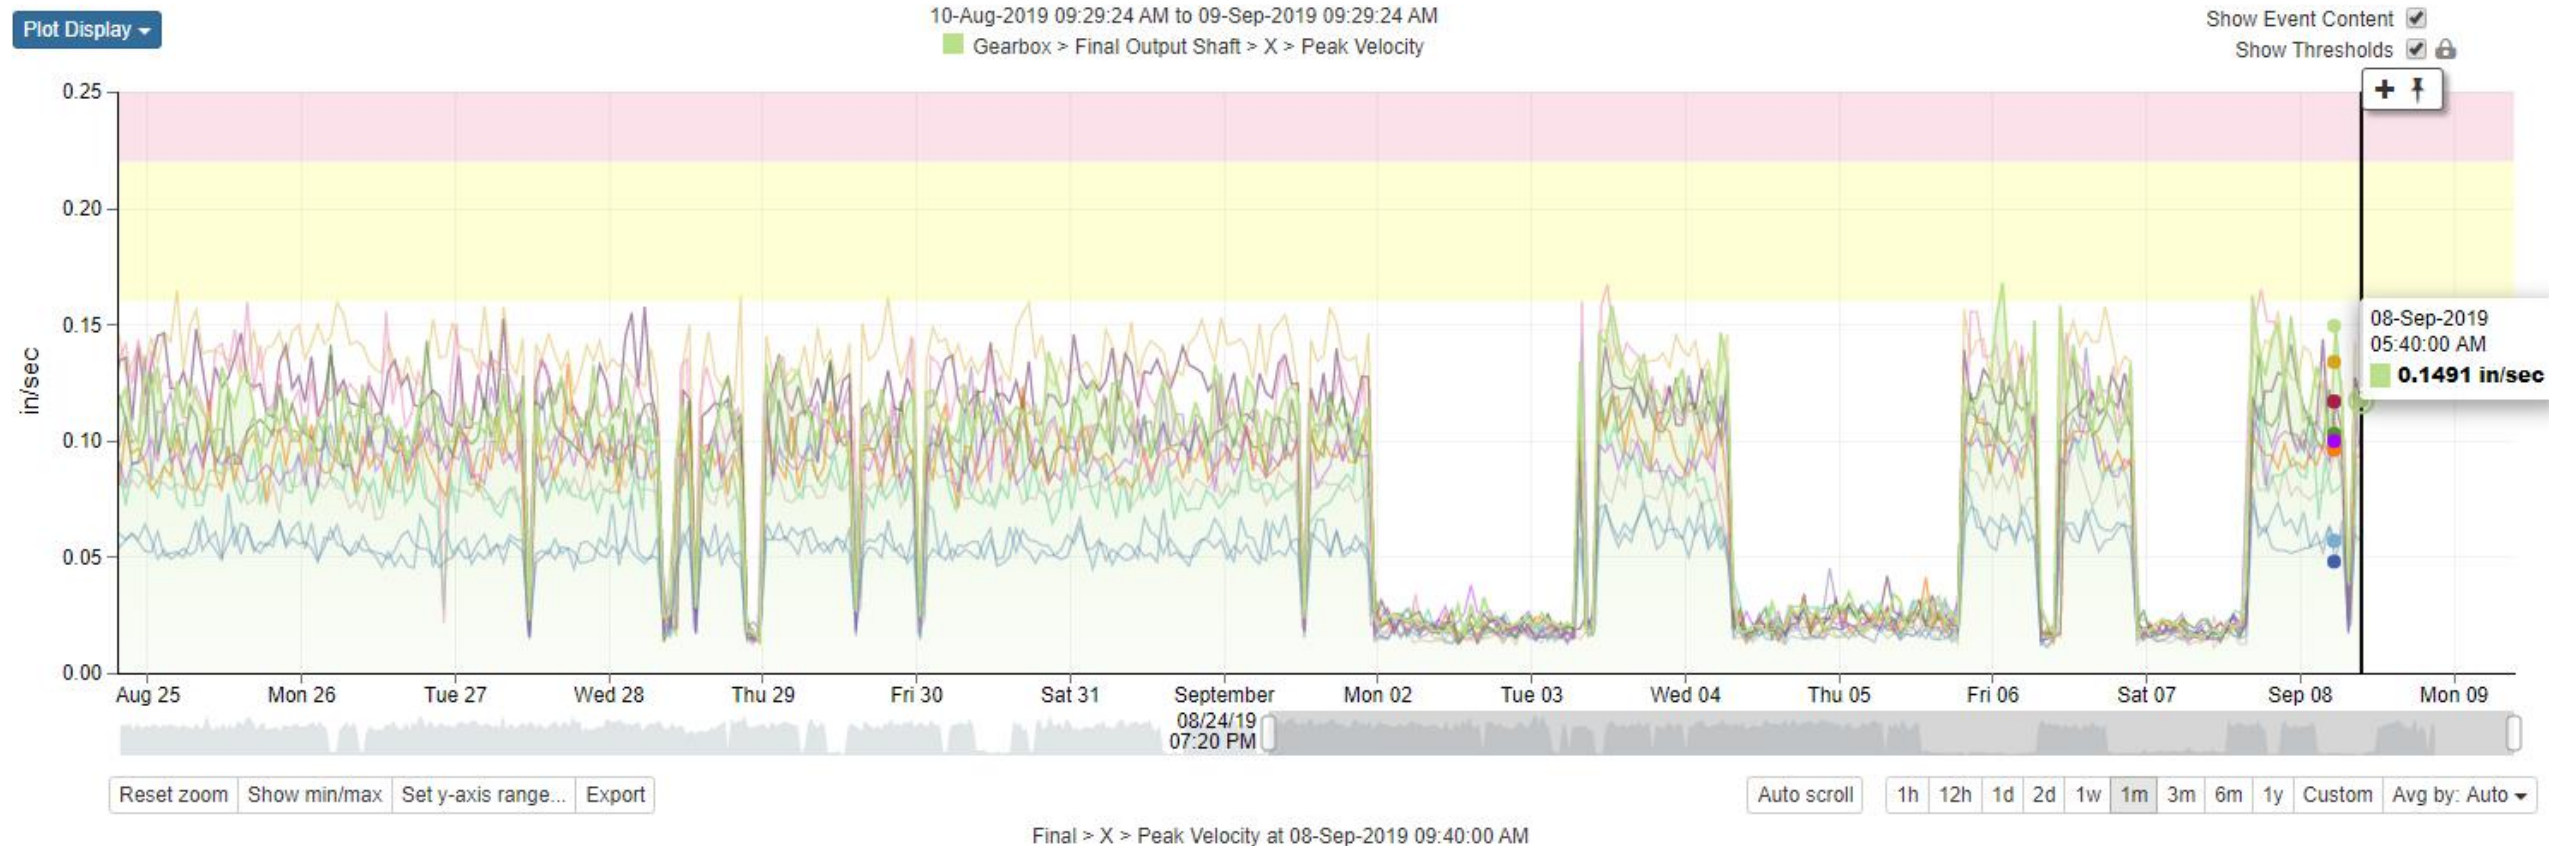
Vibration Trend Analysis

The trend chart shows vibration in Velocity values, which are keeping within the alert limits, however there are 6 events in which the global value touches the first alert limit.

Severity Criteria	Color	Description
Green	Green	= Good / Acceptable
Yellow	Yellow	= Alert / In observation
Red	Red	= Warning / Need Attention

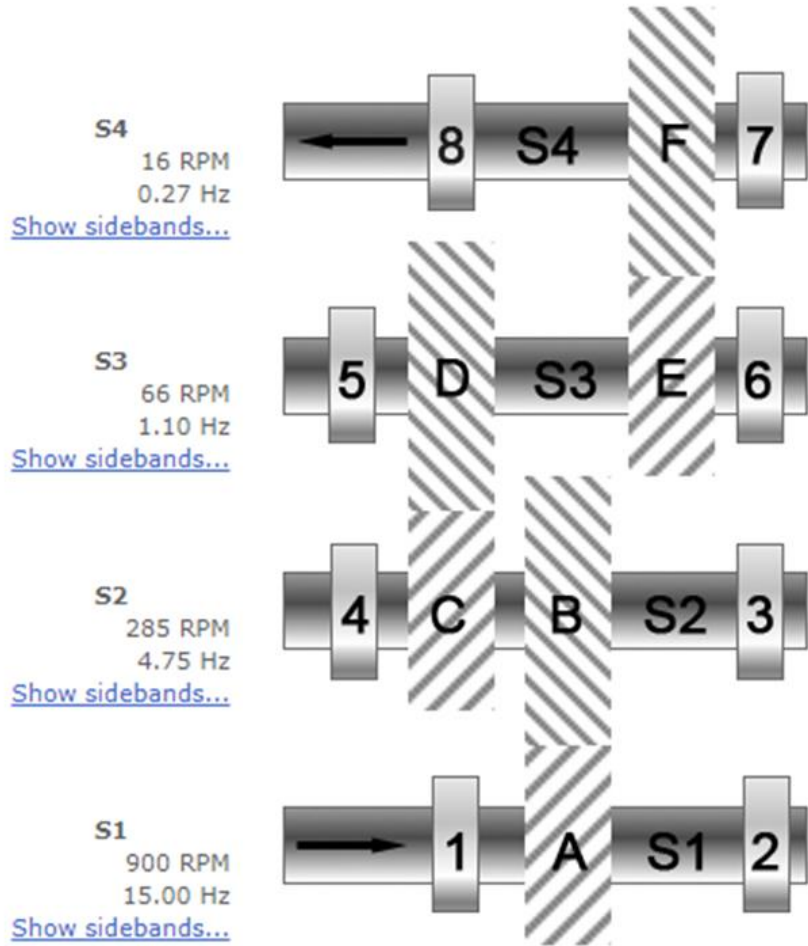
Failure Diagnostic Gears Frequencies Analysis

S4 E & F		
	CPM	Hz
-2	899	14.98
-1	915	15.25
0	931	15.52
1	947	15.78
2	963	16.05

A complete simulation of the Gearbox train was performed, to identify the specific failure frequencies for each shaft and each gear.

Shaft	Speed	Gear Teeth	GMF	GMF Orders				MA Ratio	
				S1	S2	S3	S4	S1	S4
S1	900 RPM								
	15.00 Hz	A 19	A & B	17100 CPM	19.0	60.0	257.1	1083.7	
S2	285 RPM	B 60		285.00 Hz					S2 0.317
	4.75 Hz	C 14	C & D	3990 CPM	4.4	14.0	60.0	252.9	
S3	66 RPM	D 60		66.50 Hz					S3 0.074
	1.10 Hz	E 14	E & F	931 CPM	1.0	3.3	14.0	59.0	
S4	16 RPM	F 59		15.52 Hz					S4 0.018
	0.27 Hz

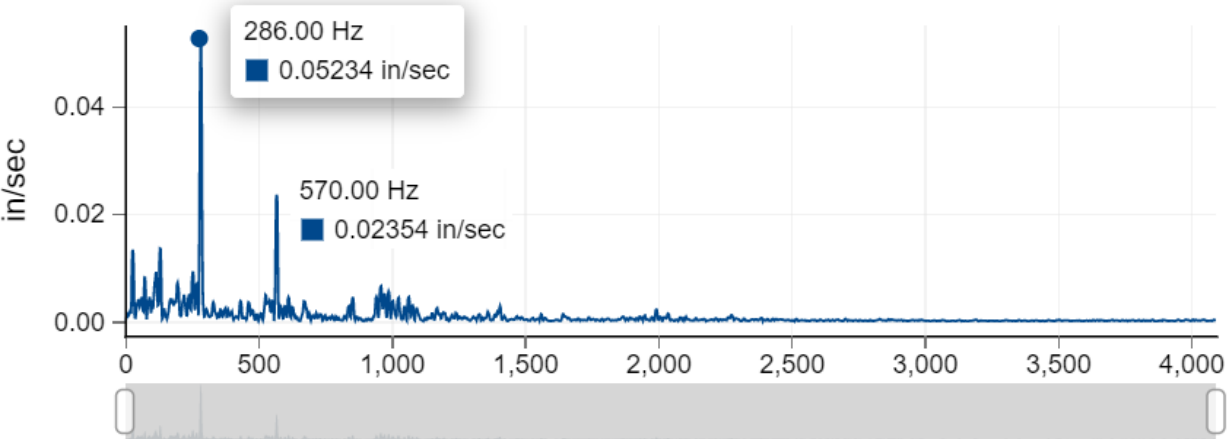
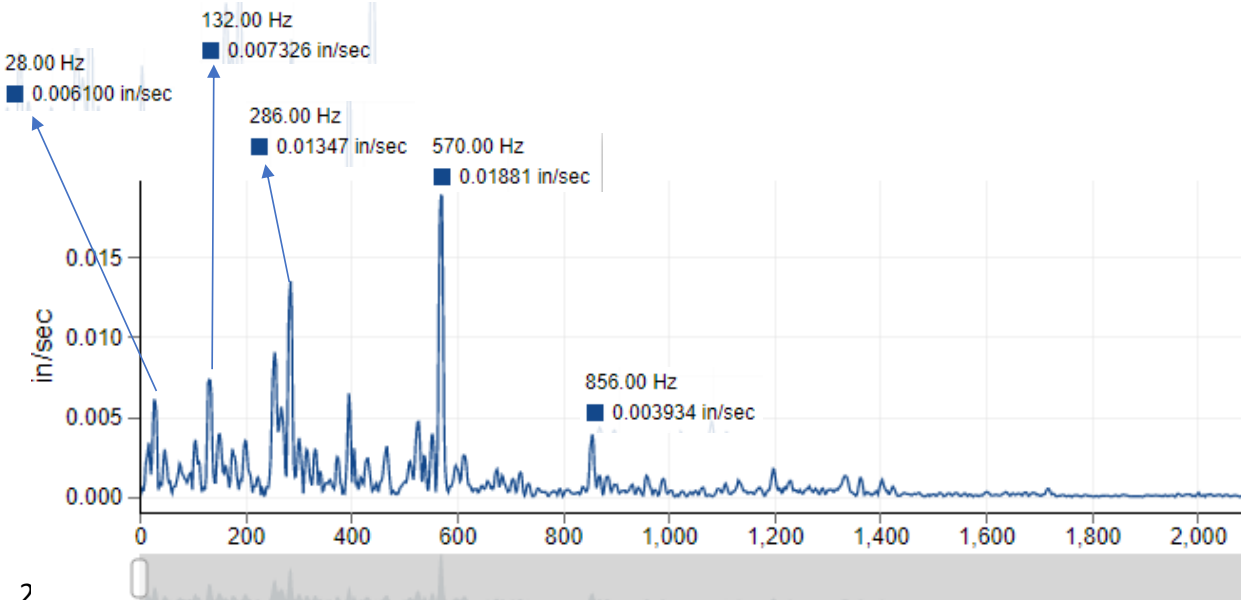
Spectrum Analysis Shaft N°1

The shaft 1 clearly shows the failure frequencies of gear teeth that are highlighted in the simulation, these correspond to 1x and 2x of the frequency of failure of the gears of shaft 2, which are transmitted to shaft 1.

With a frequency amplification, we can also observe the coupling failure frequency (28 Hz), as well as the appearance of the 3x (856 Hz) of the gear teeth failure of shaft 2.

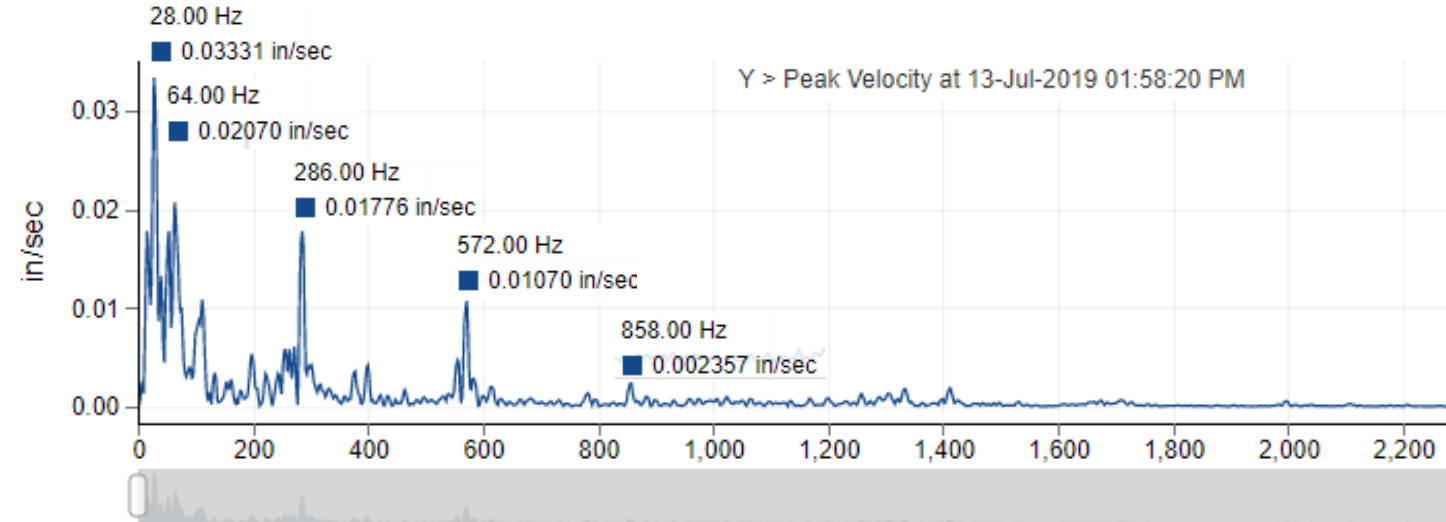
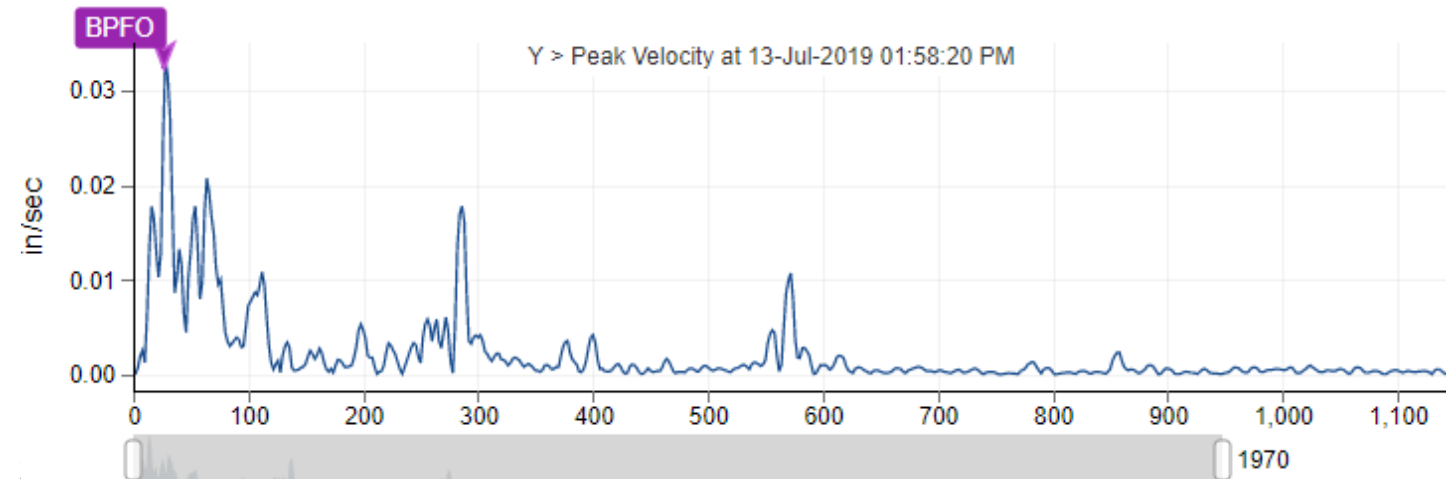
Spectrum Analysis Shaft N°2

The shaft 2 clearly shows the frequencies 1x, 2x and 3x of the gear tooth failure frequency, as well as a high amplitude in the coupling failure frequency (28 Hz) that is amplified with the BPFO frequency (Ball Pass Frequency Outer) corresponding to the shaft 2 bearing.

The gear coupling failure frequency and the shaft 2 gear tooth failure frequencies are shown again.

In the different spectral graphs, the frequency of the shaft 3 gear is also observed, which is the other frequency highlighted in the gearbox train simulation.

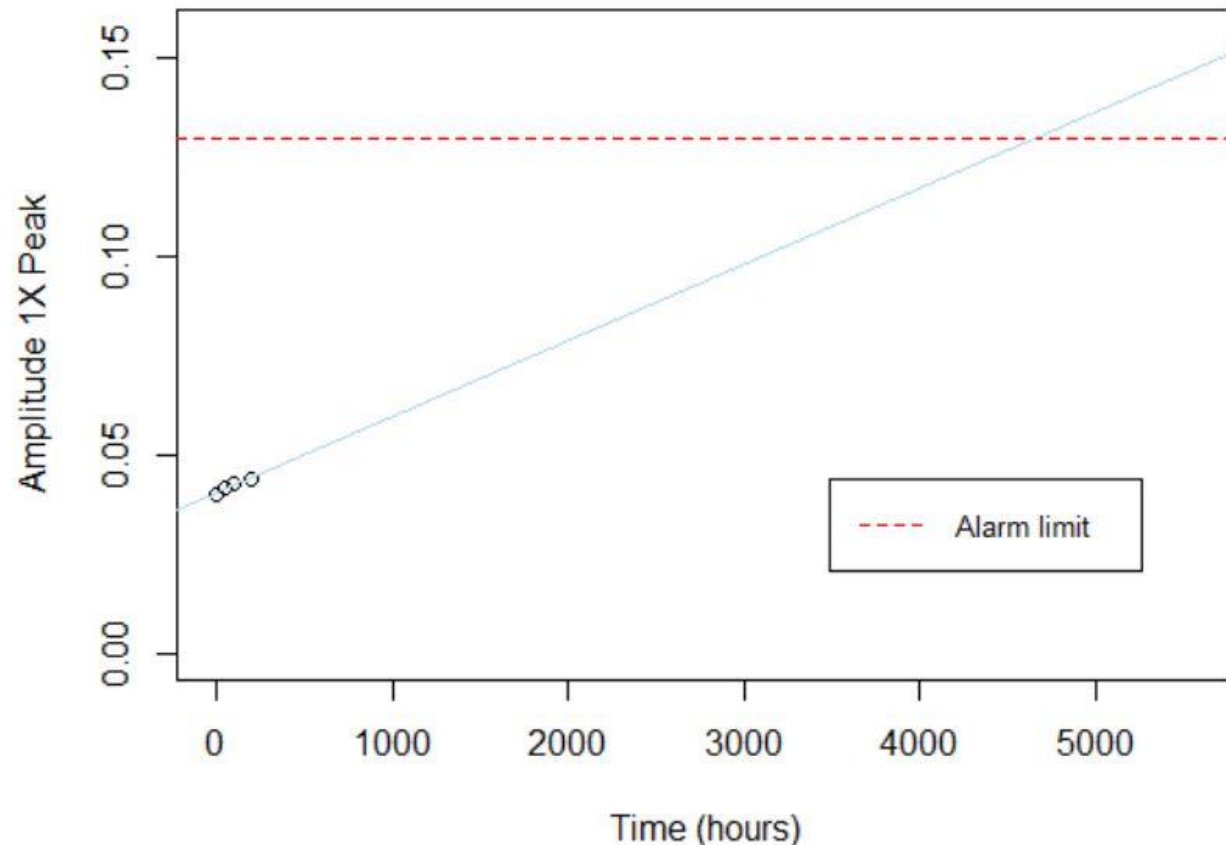
GearBox Alarm Level prediction

The degradation process is slow, however the evolution of the 1X spectra allows to predict, with low level of confidence because we have very few spectrums and very close in time to each other, that around 1X the maximum amplitude of Failure frequency **will cross the alarm limit in 4647 hours**. There is not enough data to use Neural Networks, so we use linear regression.

(Approximately **March-April 2020**)

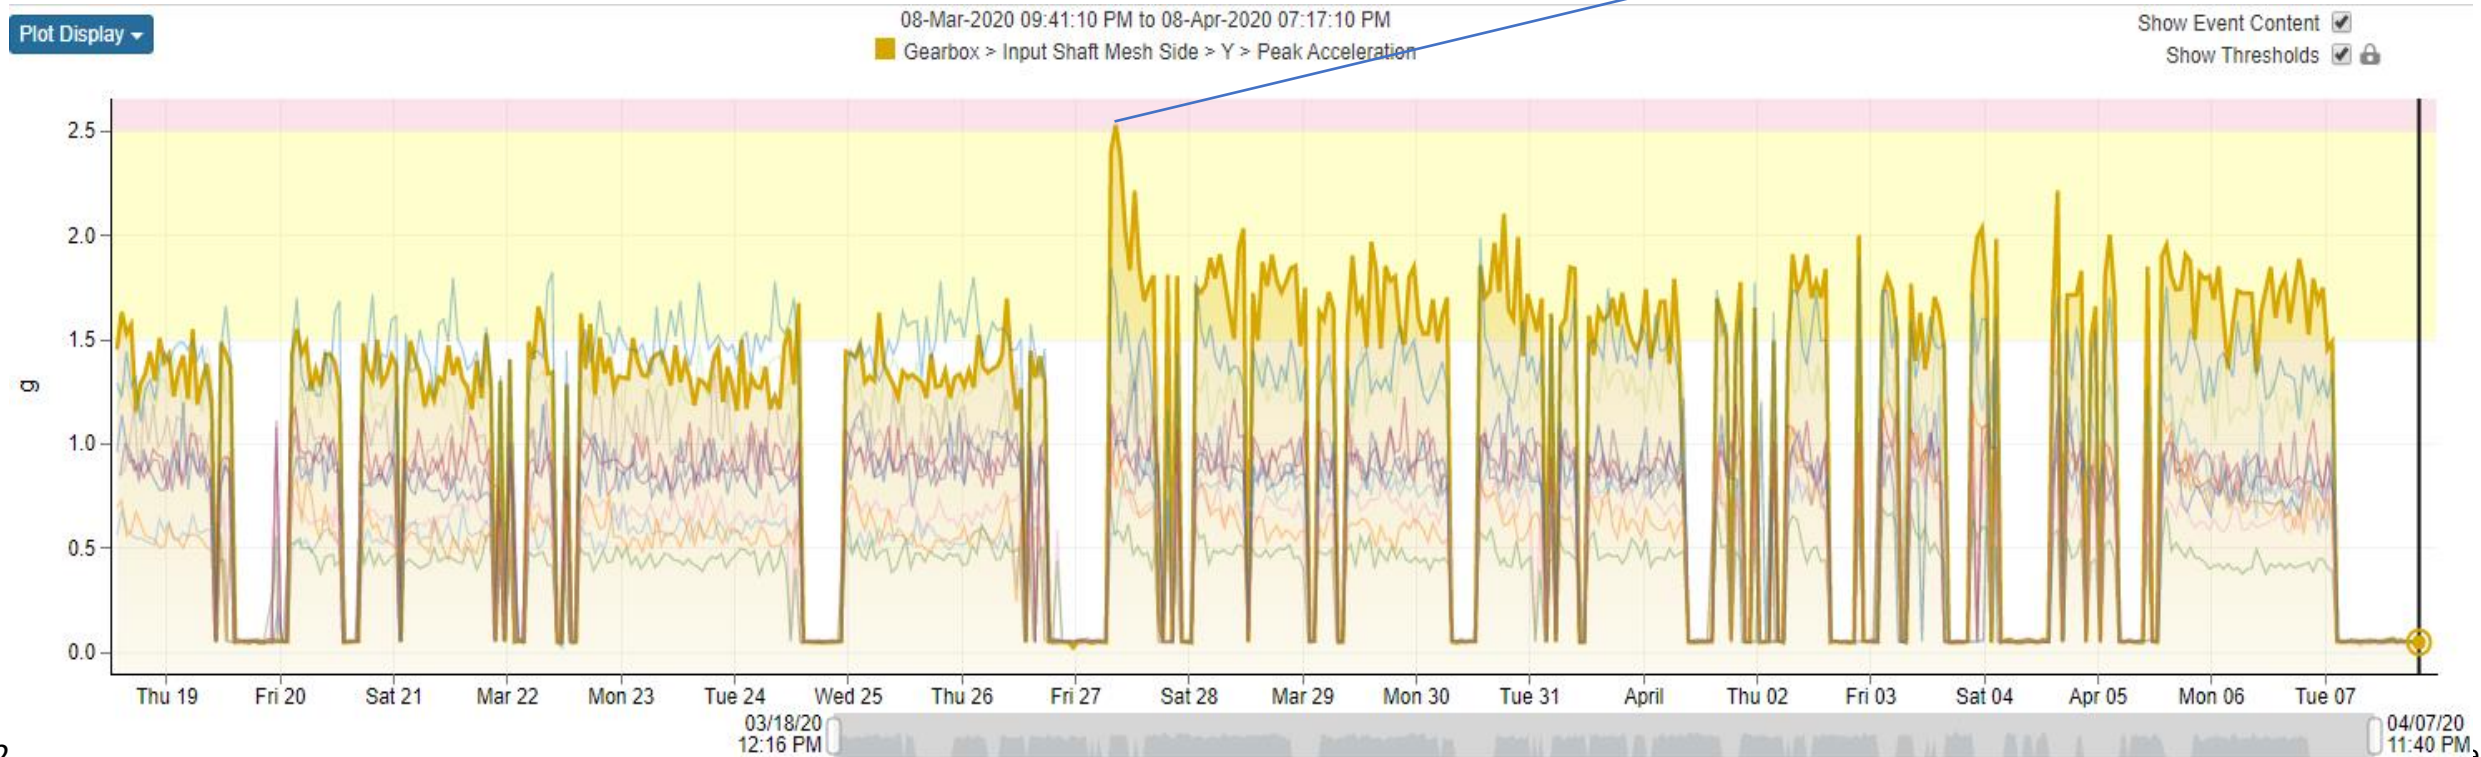
Remaining Useful Life (RUL)

The trend chart shows vibration in Velocity values, which are keeping within the alert limits.

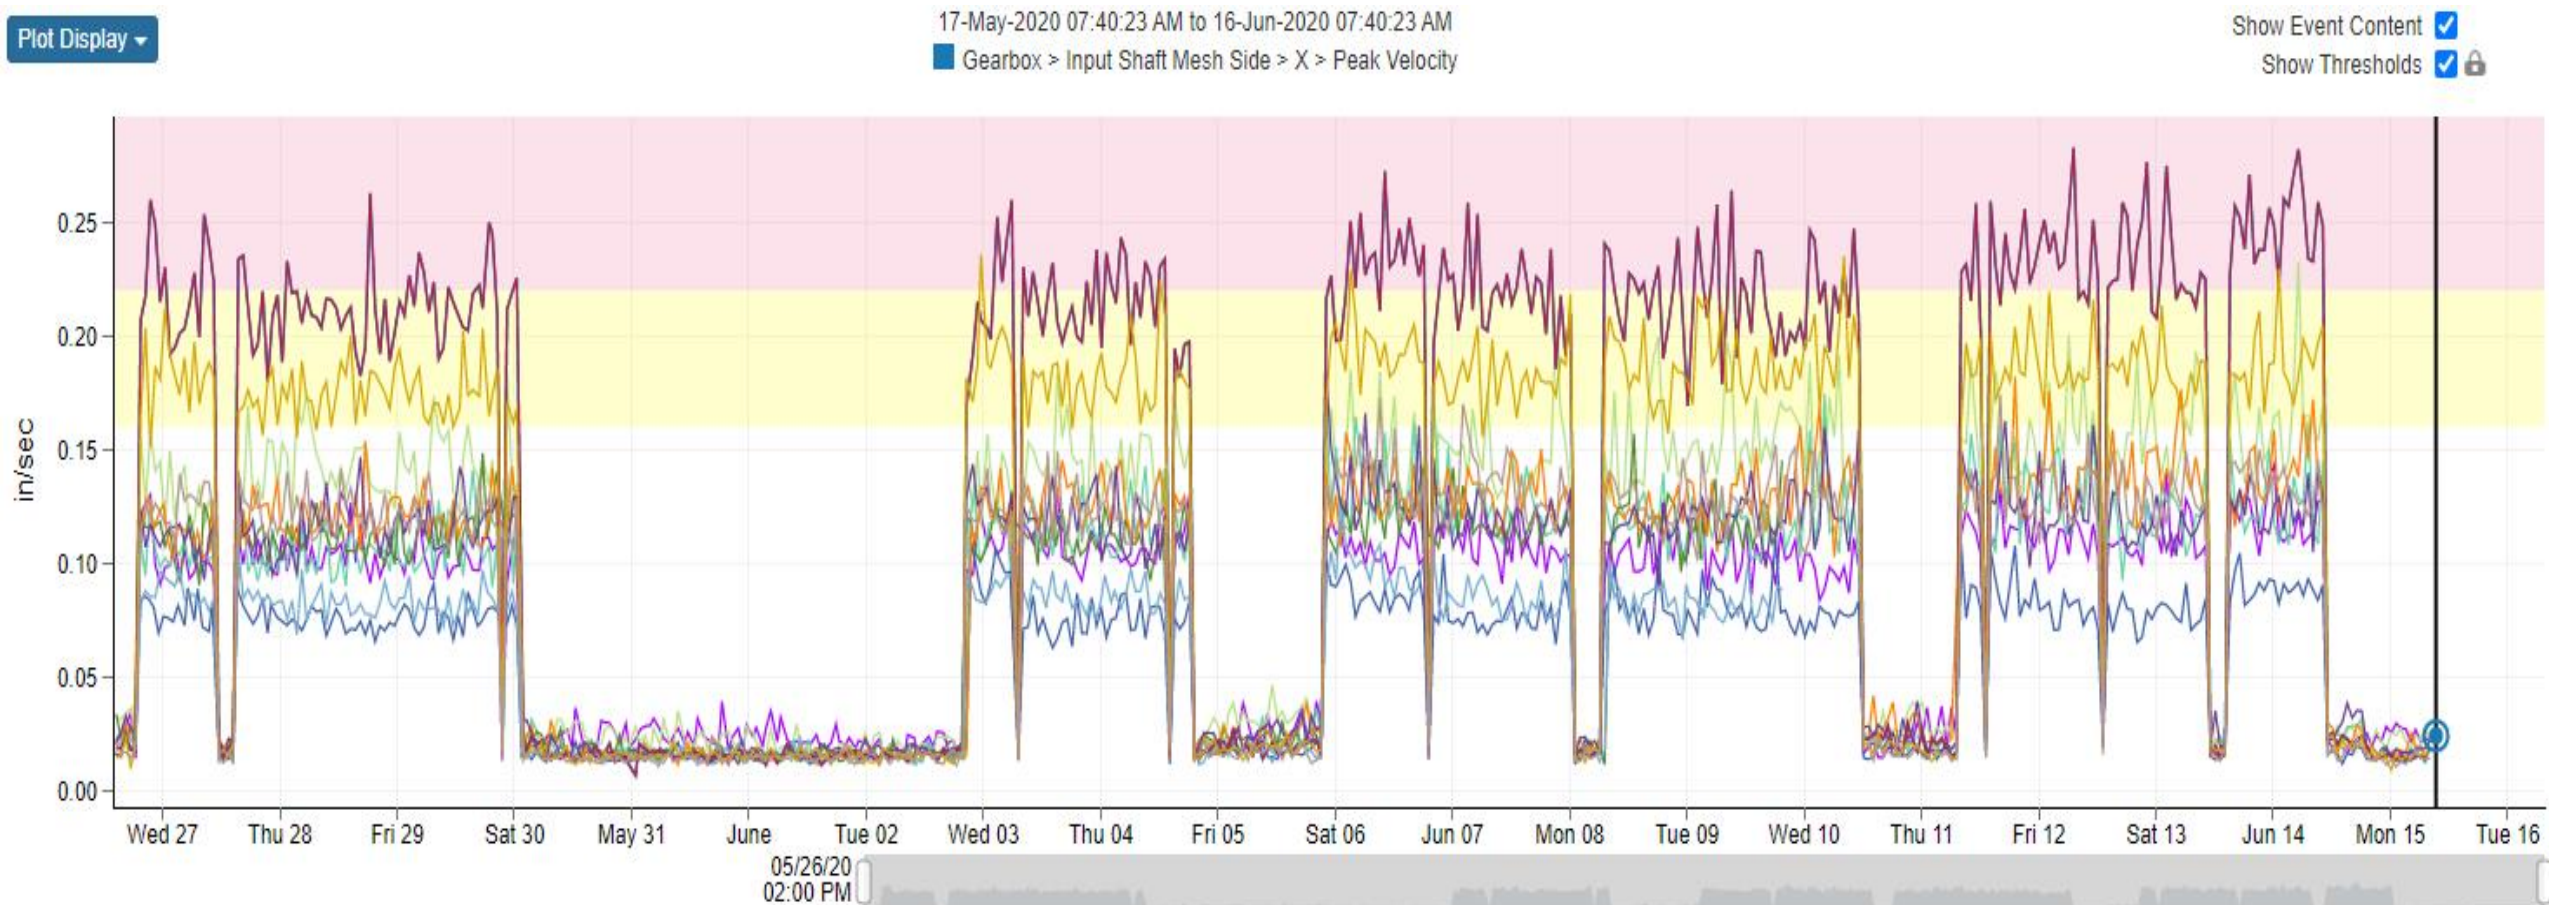
Remaining Useful Life (RUL)

1. Two cycles are clearly observed. Before and after the event that occurred on May 26th where the vibrations increased.
2. The two cycles are clearly observed on the orange curve in the frequency distribution histogram as well.
3. Based on what is described in the two previous paragraphs, the forecast will be made only with the data of the second cycle, which begins on May 26th.

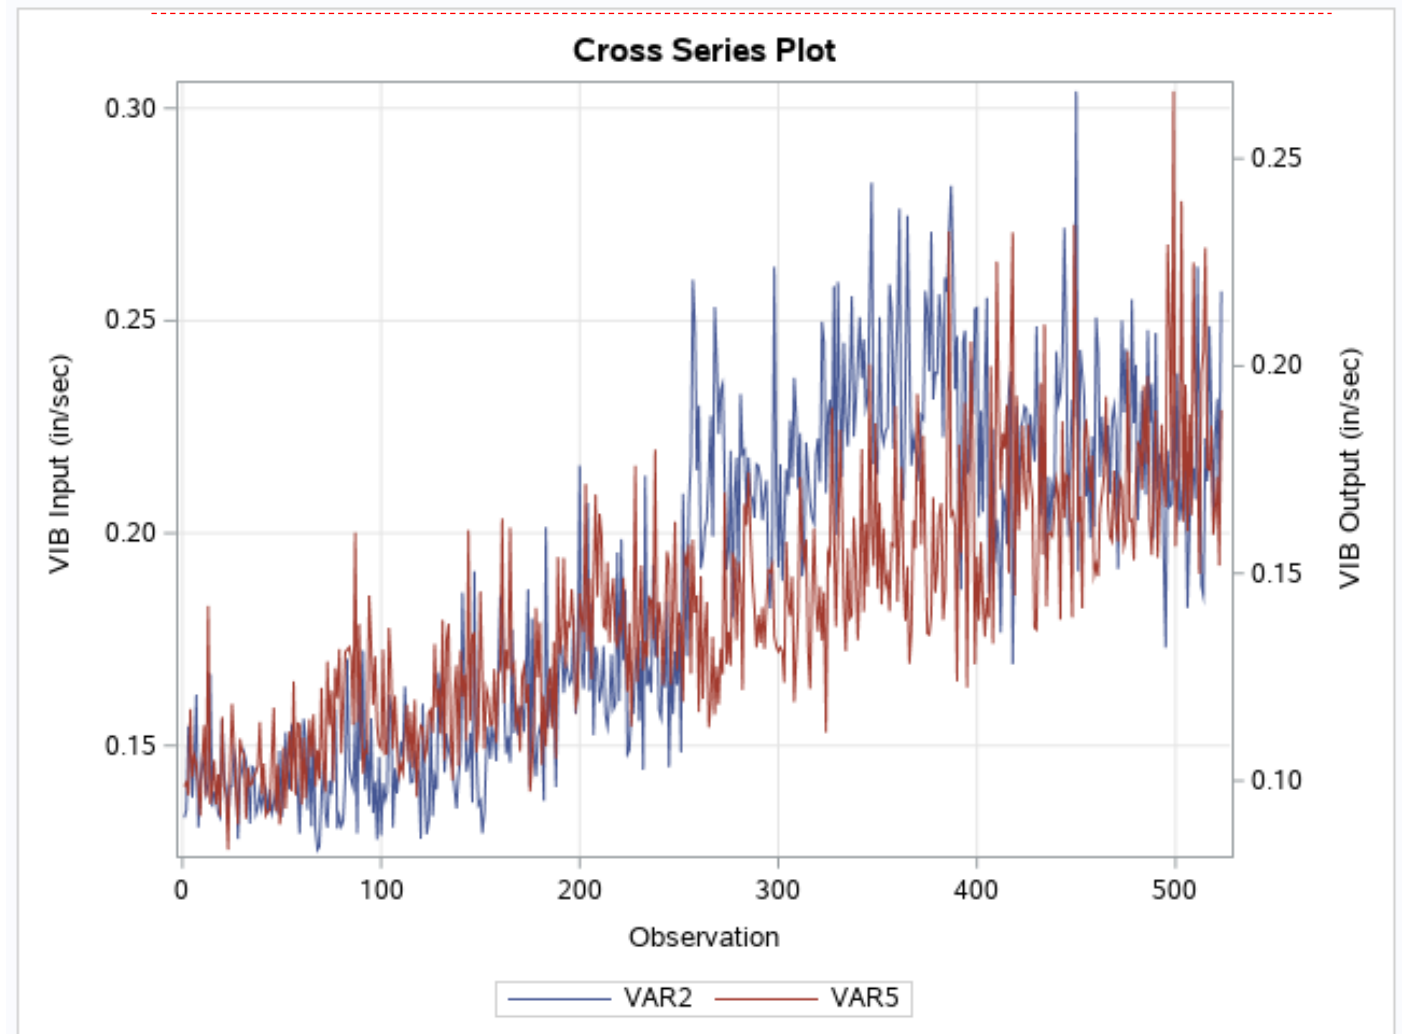
Vibration Trend:

- Input Shaft
- Output Shaft

0.30 in/Sec

July 2019 to July 2020

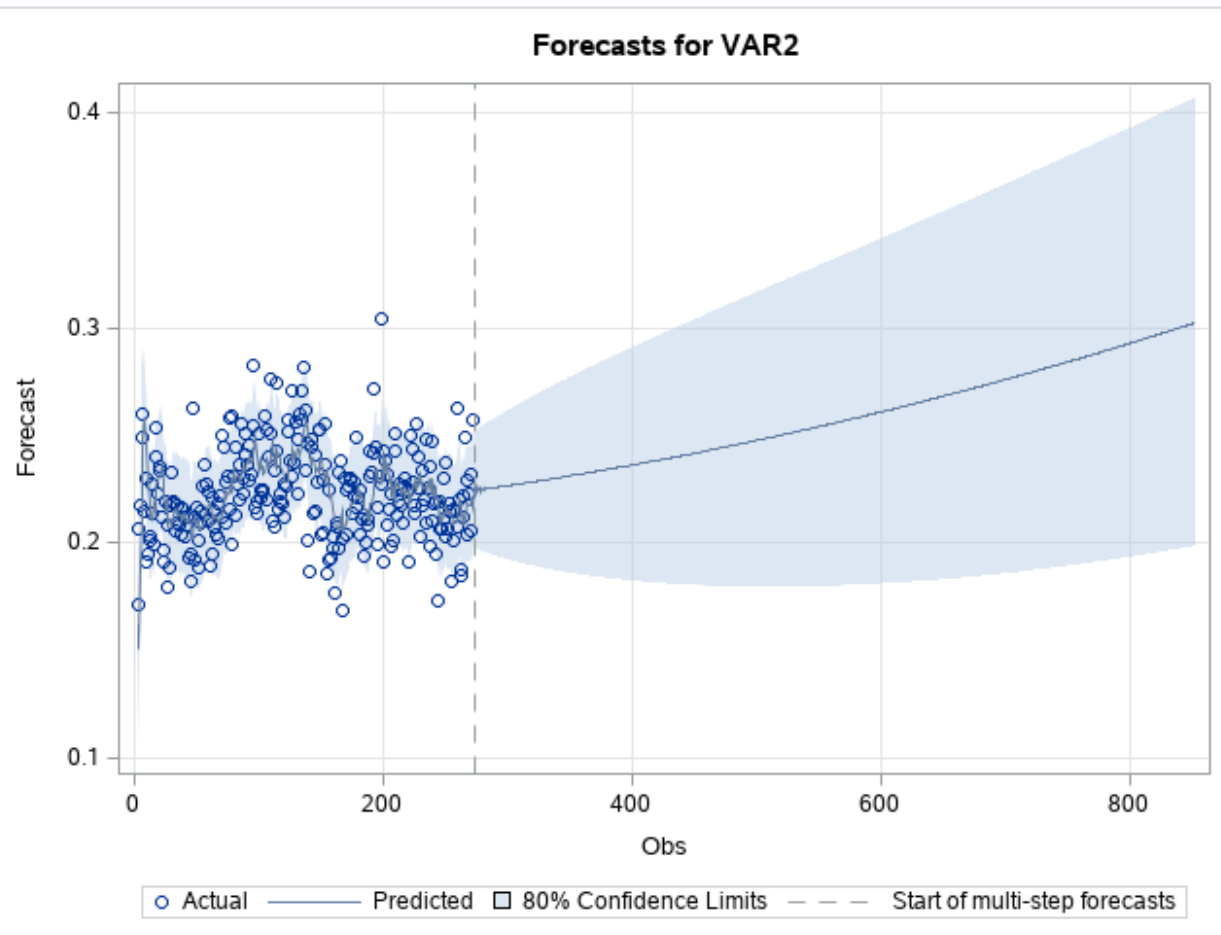
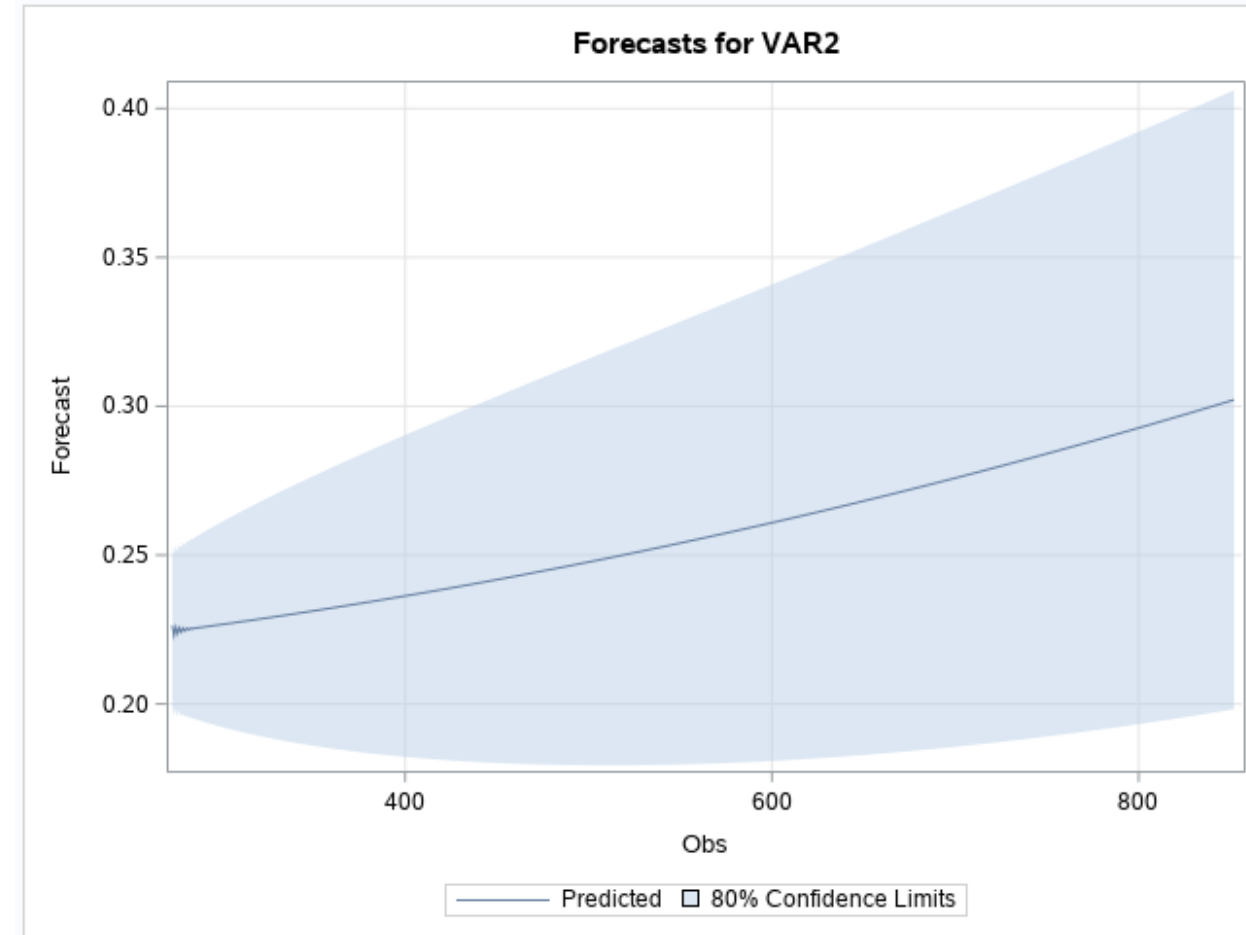
Summary:

The observations (Obs) are carried out every 1 hour, for that reason 950 Obs are approximately 950 Hours \approx 40 Days.

Vibration Prognosis \geq 0.40 IPS \approx August 9, 2020.
