DA FORM 2410 USABILITY FOR RELIABILITY ANALYSIS

Timothy Willis RIMFIRE Engineering Services

> RAM X Training Summit Nov 2017

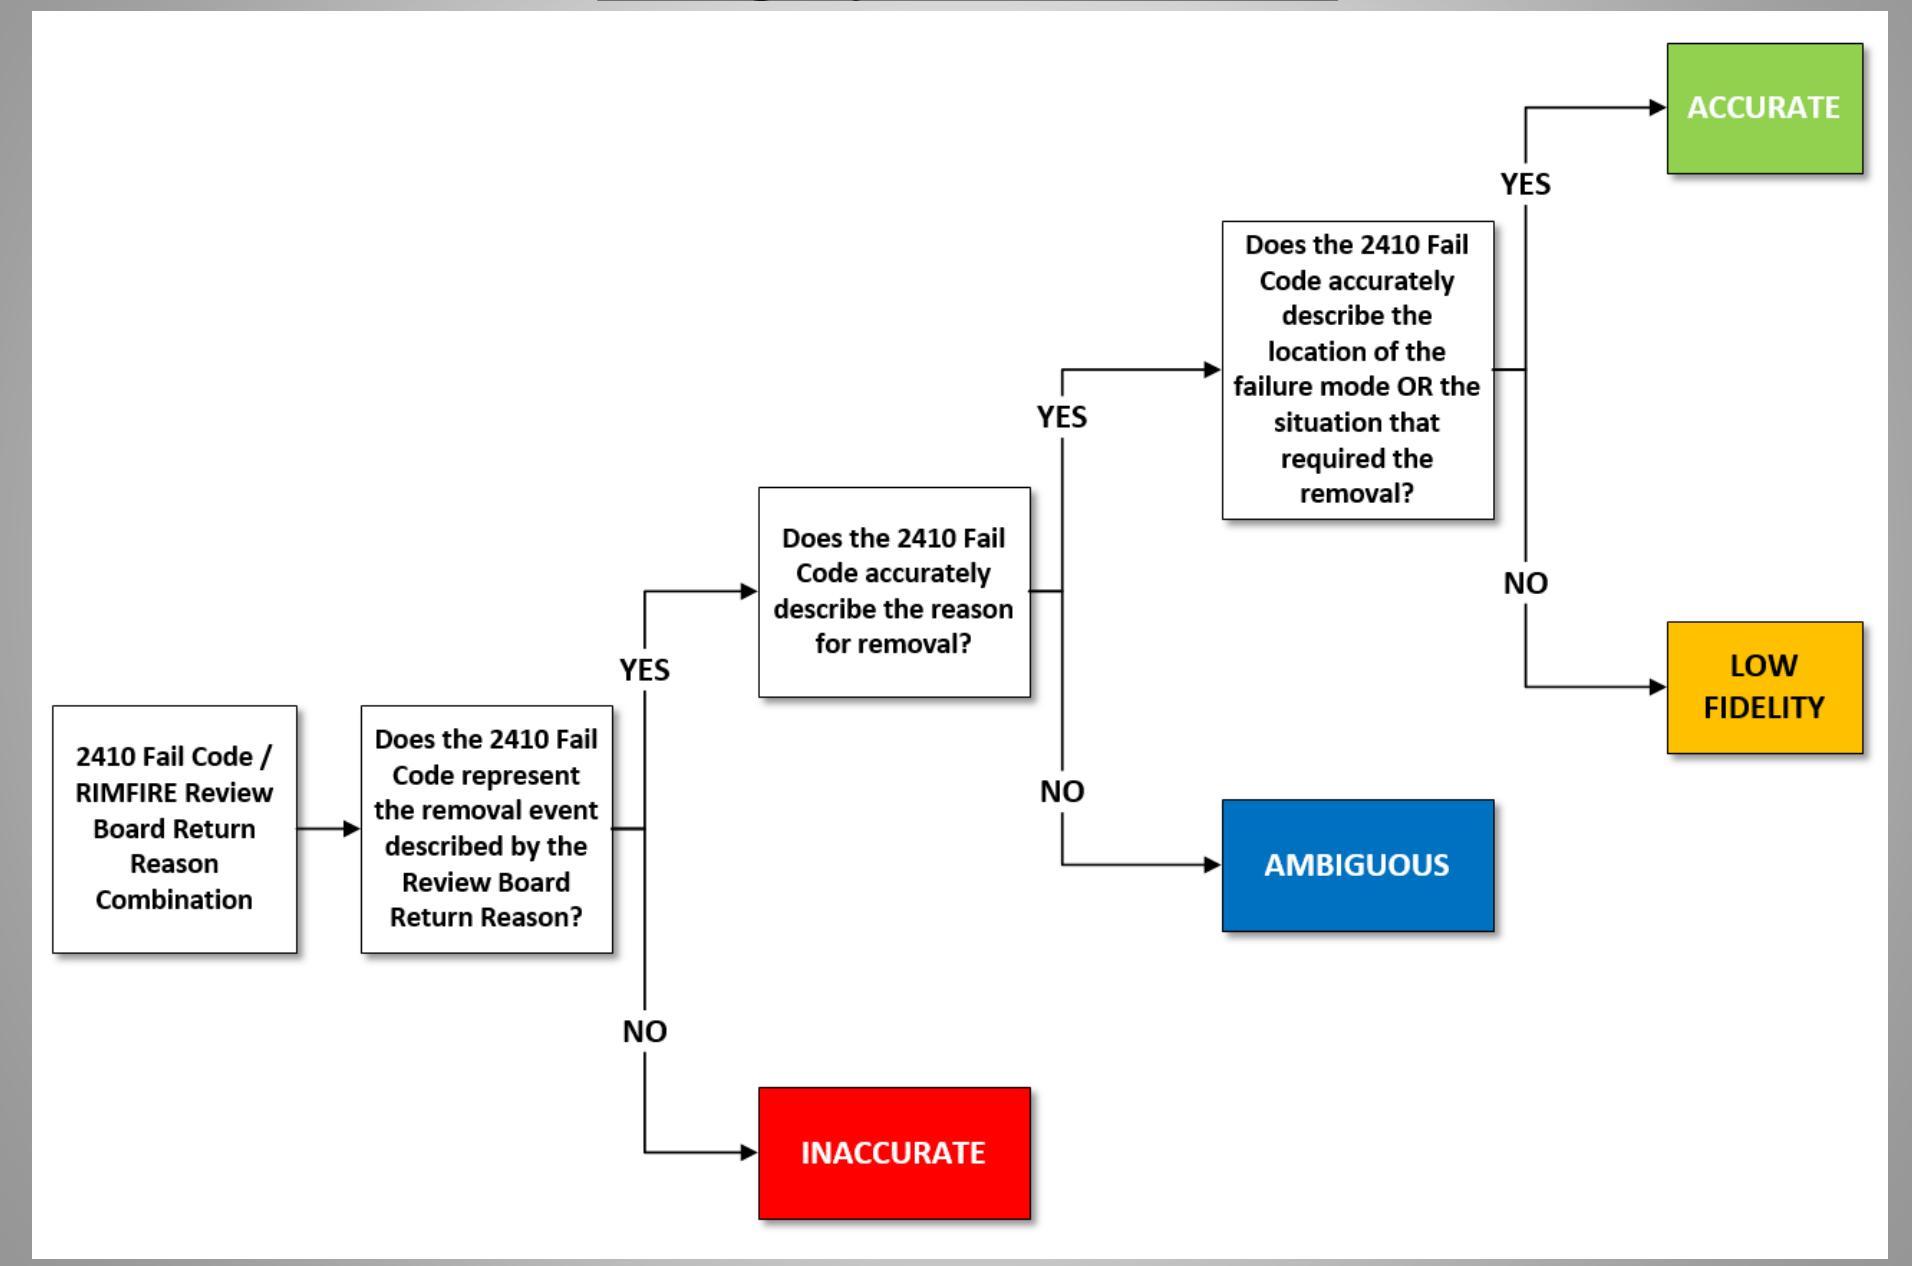
Exact:

The 2410 Fail Code accurately represents the removal event described by the RIMFIRE Review Board Return Reason, and describes the location of the failure or situation that required the removal.

Low Fidelity:

The 2410 Fail Code accurately represents the removal event described by the RIMFIRE Review Board Return Reason, but does not describe the location of the failure or situation that required the removal.

Ambiguous:

The 2410 Fail Code represents the removal event described by the RIMFIRE Review Board Return Reason, but not accurately enough for a reliability assessment.

Wrong:

The 2410 Fail Code does not represent the removal event described by the RIMFIRE Review Board Return Reason.

- Using this column, establish the full array of combinations that occur in the dataset.
 - Grade accuracy of each combination using Category Decision Tree (Slide 5)

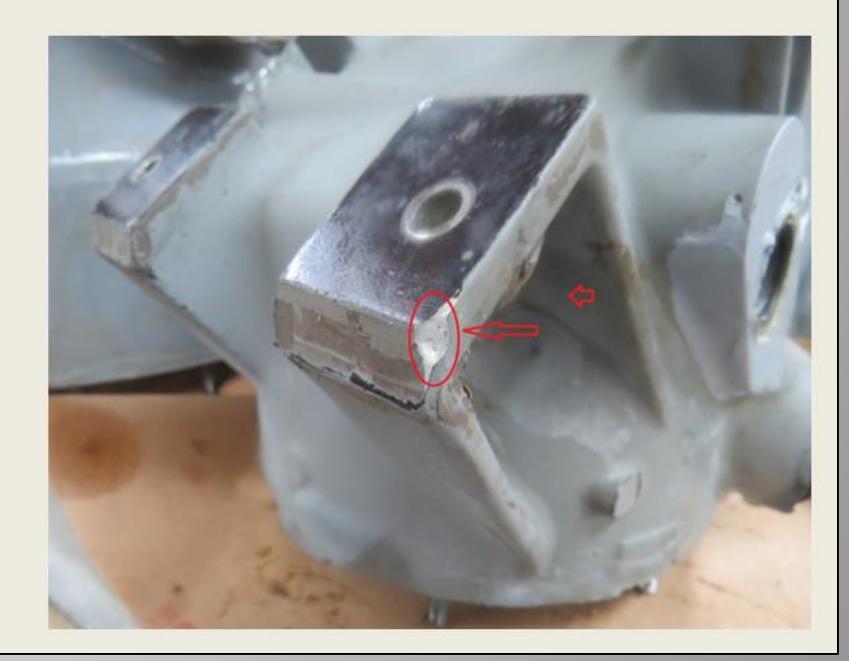
Example of a "Low Fidelity" record score

UH-60A, Intermediate Gearbox Field Removal: 8-Dec-2014 TSN: 4993 hrs

- 2410 Fail Code: 170 Corroded
- RIMFIRE Board Return Reason: Corrosion
- Fail Tag states Corroded beyond limits
- 2410 Remarks state RESET ACFT 8123619 UH60A 5709.5 ACFT HRS
- No specific Logbook entry found.
- RIMFIRE inspector found corrosion on the center housing mounting foot.

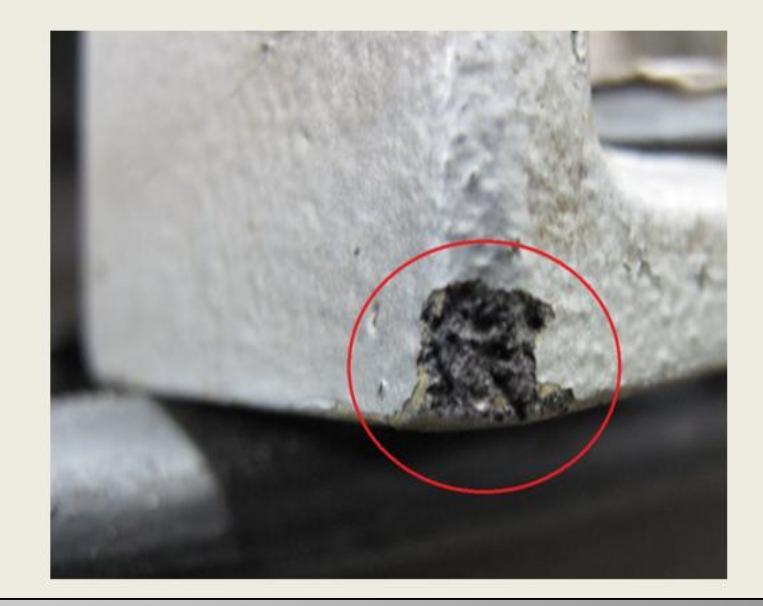
Example of an "Ambiguous" record score

UH-60A, Intermediate Gearbox Field Removal: 25-Oct-2012 TSN: 4866 hrs

- 2410 Fail Code: 705 Beyond specified tolerance
- RIMFIRE Board Return Reason: Corrosion
- Fail Tag states Corroded beyond limits
- No 2410 remarks.
- No specific Logbook entry found.
- RIMFIRE inspector found heavy pitting on the center housing mounting feet. Other corrosion and typical wear found.

) HEAVY PITTING ON THE CENTER HOUSING MOUNTING FEET. P/N 70357-06305-042 S/N A315-00214 2) HEAVY WEAR GROOVES ON THE OUTPUT FLANGE ASSEMBLY. P/N 70357-06116-041 S.N C0210 3) HEAVY CORROSION IN THE OUTPUT BEVEL GEAR SPLINES. P/N 70357-06315-101 S/N C318-00355 3) HEAVY CORROSION (RUST) ON THE INPUT FLANGE SPLINES. P/N 70357-06116-041 S/N C0211

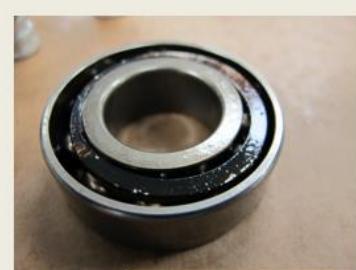
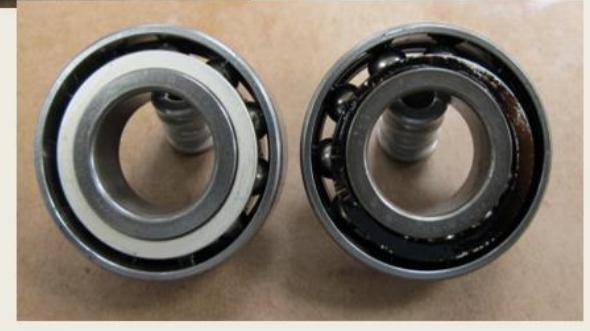
Example of a "Wrong" record score

AH-64D, T700-GE-701D

- 2410 Fail Code: 799 Serviceable, no defect
- RIMFIRE Board Return Reason: Internal Failure
- No fail tag.
- DA Form 2410 indicates engine was returned in a serviceable condition, 3 LIGHT DIRT ACCUMULATION ON STAGE 2 FORWARD GG COOLING PLATE with no defect.

- RIMFIRE Engineering Assessment: This Engine was returned due to metal on magnetic plug caused by a damaged Axis A DuplexBall Bearing with cage wear that was in the process of failing. A PQDR was submitted on the Axis A Bearing (See attached PDFs). Examination of the bearing revealed that the bearing was unserviceable and "THE MANUAL ROTATION OF THE AXIS-A BEARING, BALL DUPLEX, (P/N 4040T20P03, S/N NHAD3819), PRODUCED NOISE AND WAS ROUGH TO THE TOUCH. ONCE THE BEARING WAS REMOVED FROM THE GEARBOX, AN ASSESSMENT OF THE BEARING REVEALED MODERATE COKING, NUMEROUS SCOURED BEARING BALLS AND EVIDENCE OF HEAVY BEARING CAGE WEAR".

WORN BEARING CAGE ON AXIS A DUPLEX BALL BEARING HEAVY COKING ON DUPLEX BALL BEARING ENGINE 1. HEAVY DIRT ACCUMULATION ON STAGE 1 FORWARD GG COOLING PLATE 4. LIGHT EROSION ON 1ST STAGE COMPRESSOR BLADES 5. 2 EACH CLIPPED BLADES ON COMPRESSOR ROTOR 1ST 6. FAIL TAG MISSING

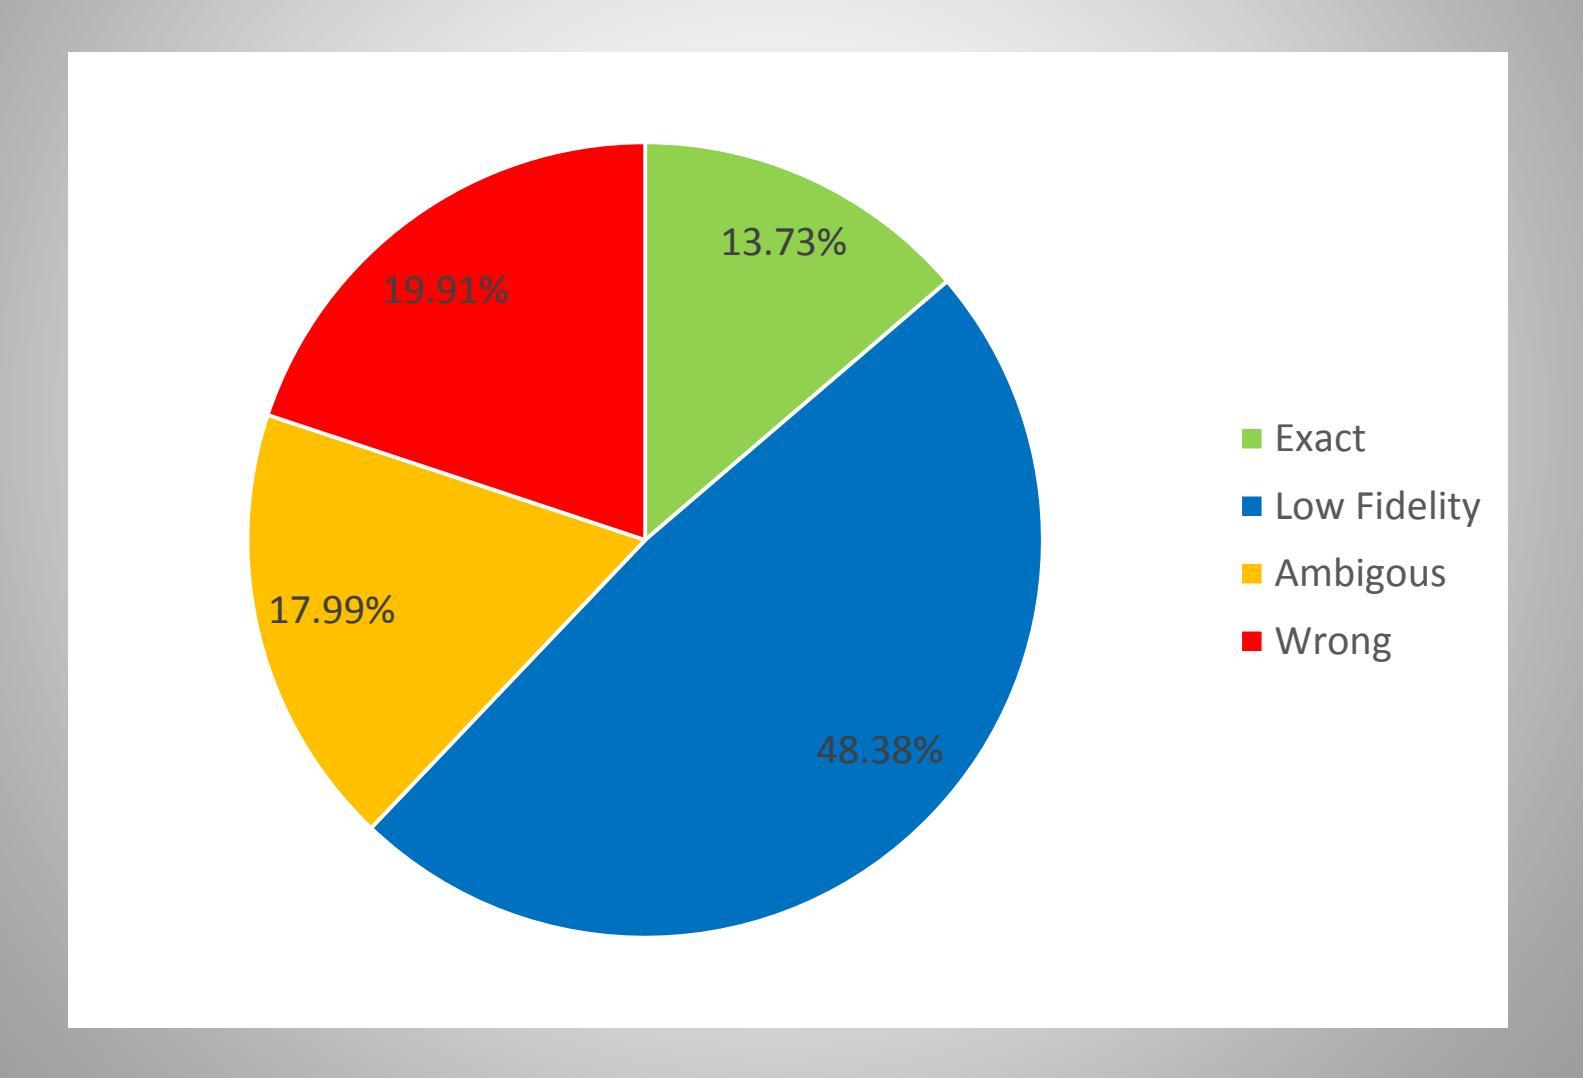
Top 10 2410 Fail Codes Rollup

***Top 10 Fail Codes account for 57.80% of the dataset
